## **Status Review of On-Site Sewage Disposal in the Unserviced Areas near Parlee Beach**

**Submitted to:** NB Department of Health  
520 King Street, HSBC Place  
Fredericton NB  
E3B 6G3

**Prepared by:** NATECH Environmental Services Inc.  
2492 Route 640  
Hanwell, N.B.  
E3E 2C2

**Date:** December 15, 2017

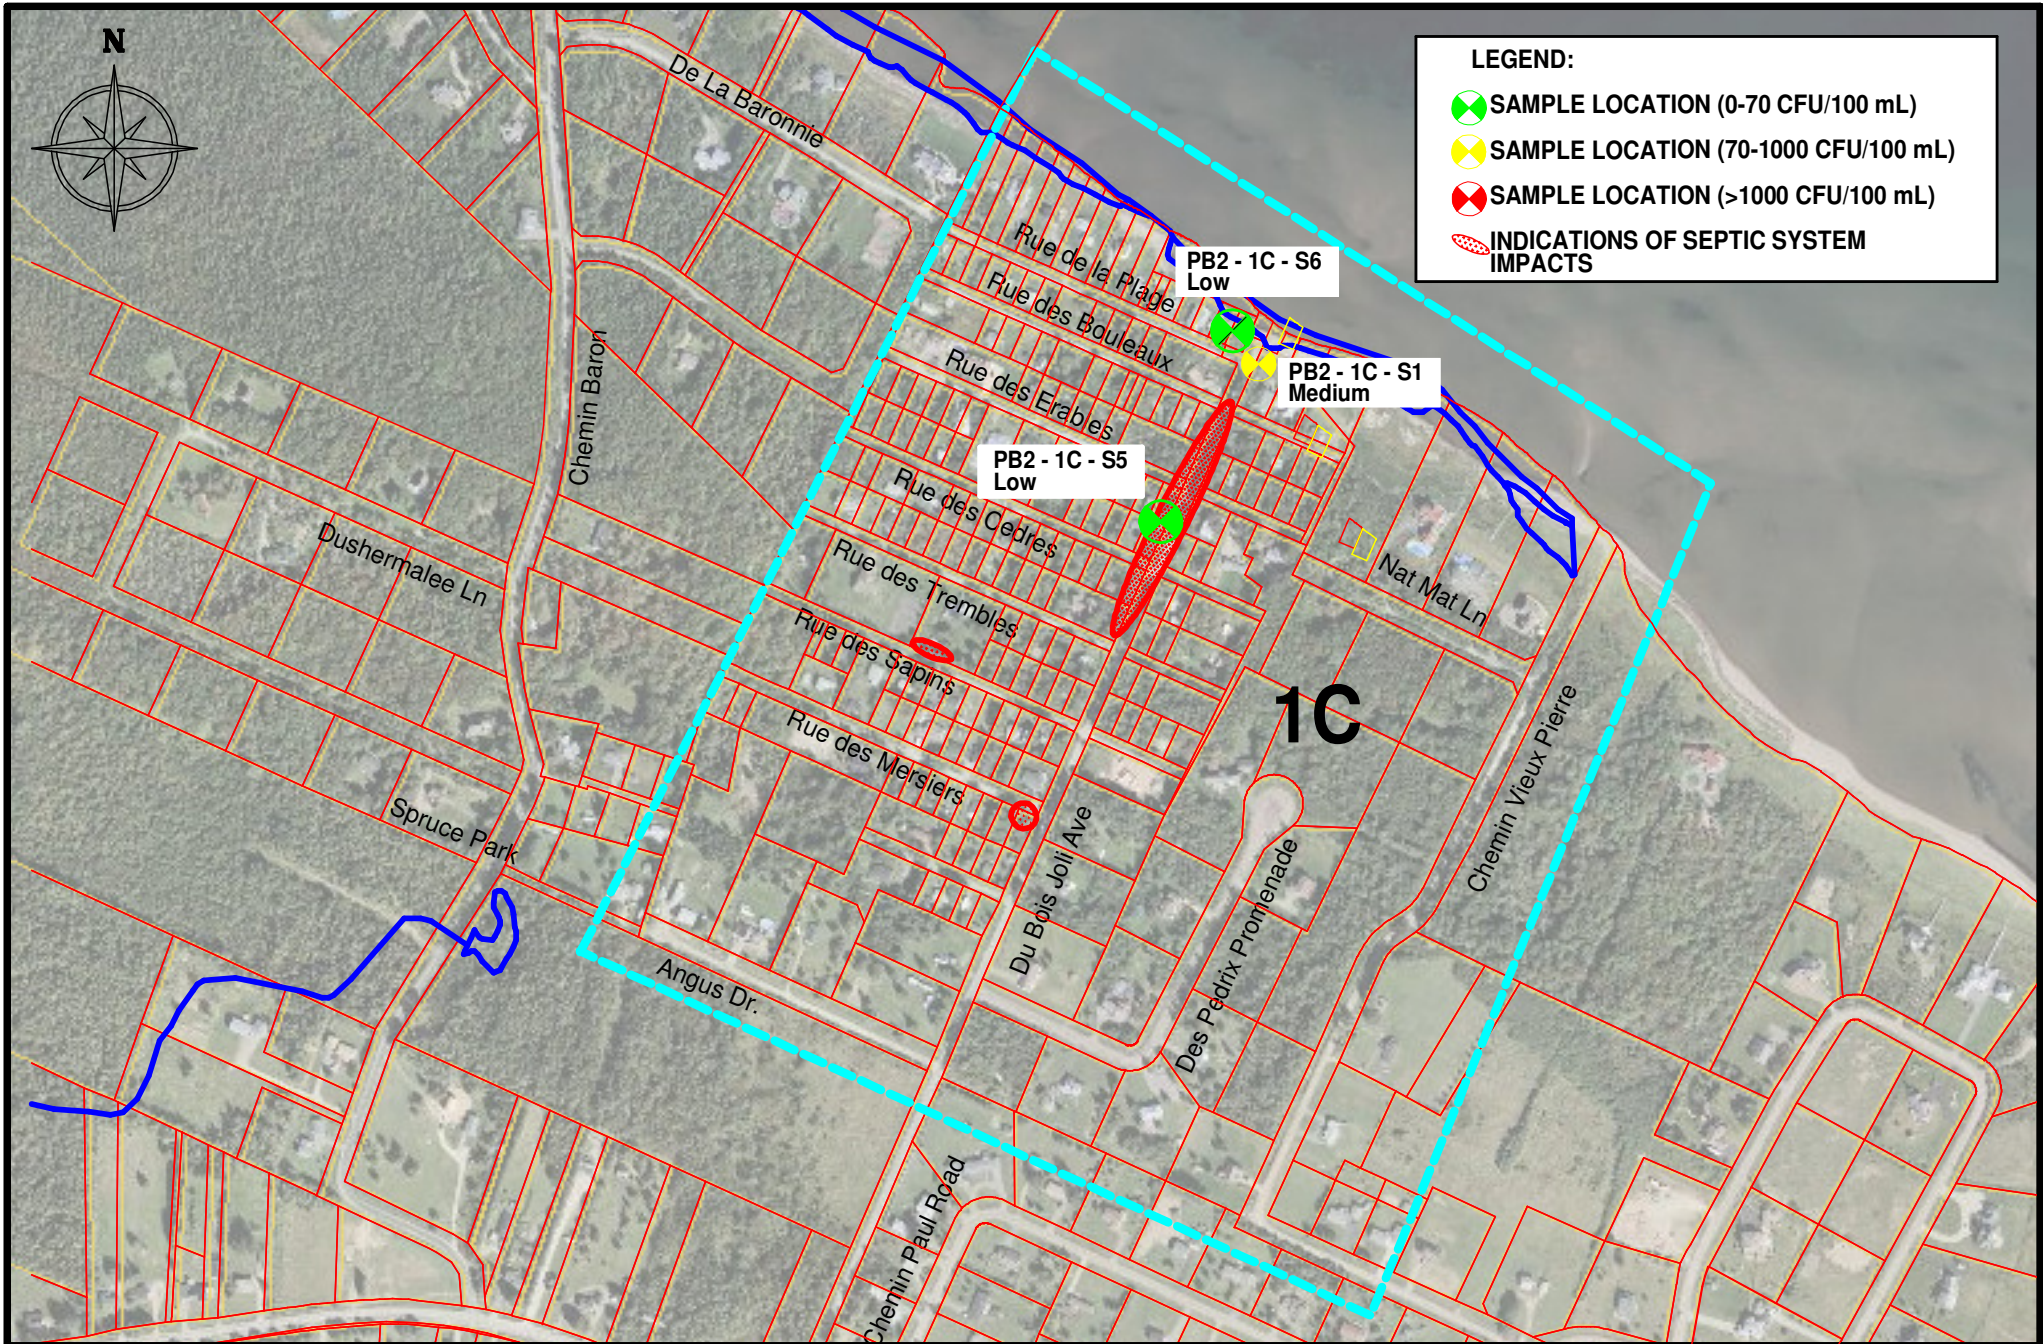
Project No.:  
PBS-17-01  
Figure:  
3-7

Assessment of On-Site Effluent Disposal Systems  
in the Unserviced Areas Near Parlee Beach  
Area 1C Test Results

A third location of interest was found in Area 1C. This area was found to have an abundance of *Impatiens capensis* (spotted touch-me-not or jewelweed) that may be indicative of septic system impacts. The ditches in the area were dry during all site visits and samples could not be taken.

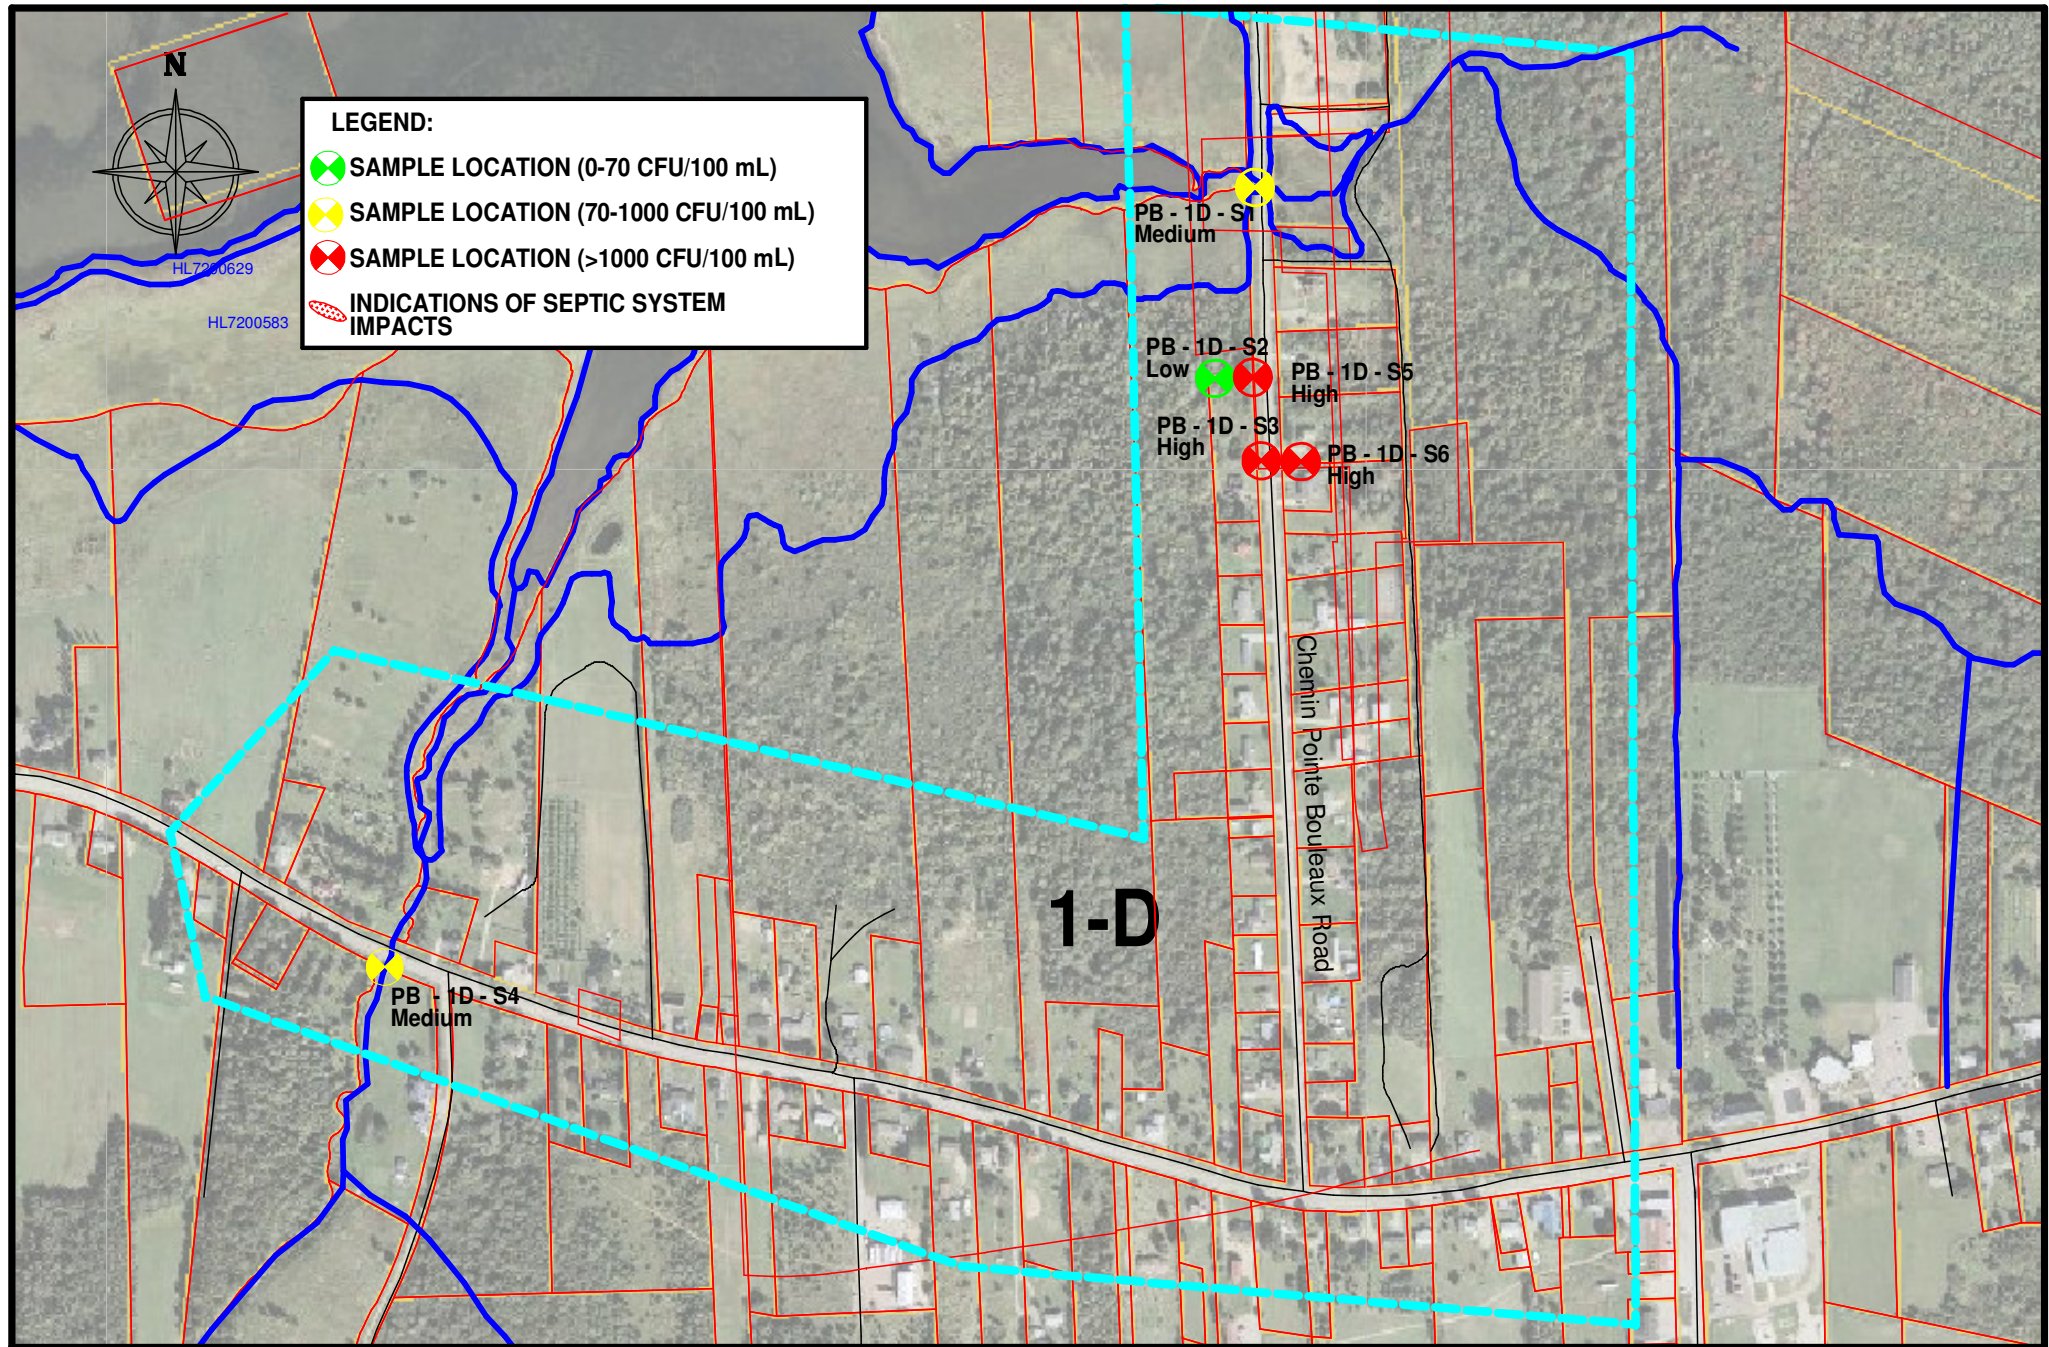
Figure: 3-8

Assessment of On-Site Effluent Disposal Systems  
in the Unserviced Areas Near Parlee Beach  
Area 1D Test Results

A ditch across the street from 63 Chemin Pointe aux Bouleaux in Area 1D, was found to have E. Coli concentrations of 5,600 cfu/100 mL. A repeat sample showed even higher concentrations. The ditch was observed to have an abundance of vegetation.

The ditch directly in front of 63 Chemin Pointe aux Bouleaux, was found to have low levels of E. Coli; however, duckweed was observed, as well as a foul odour.

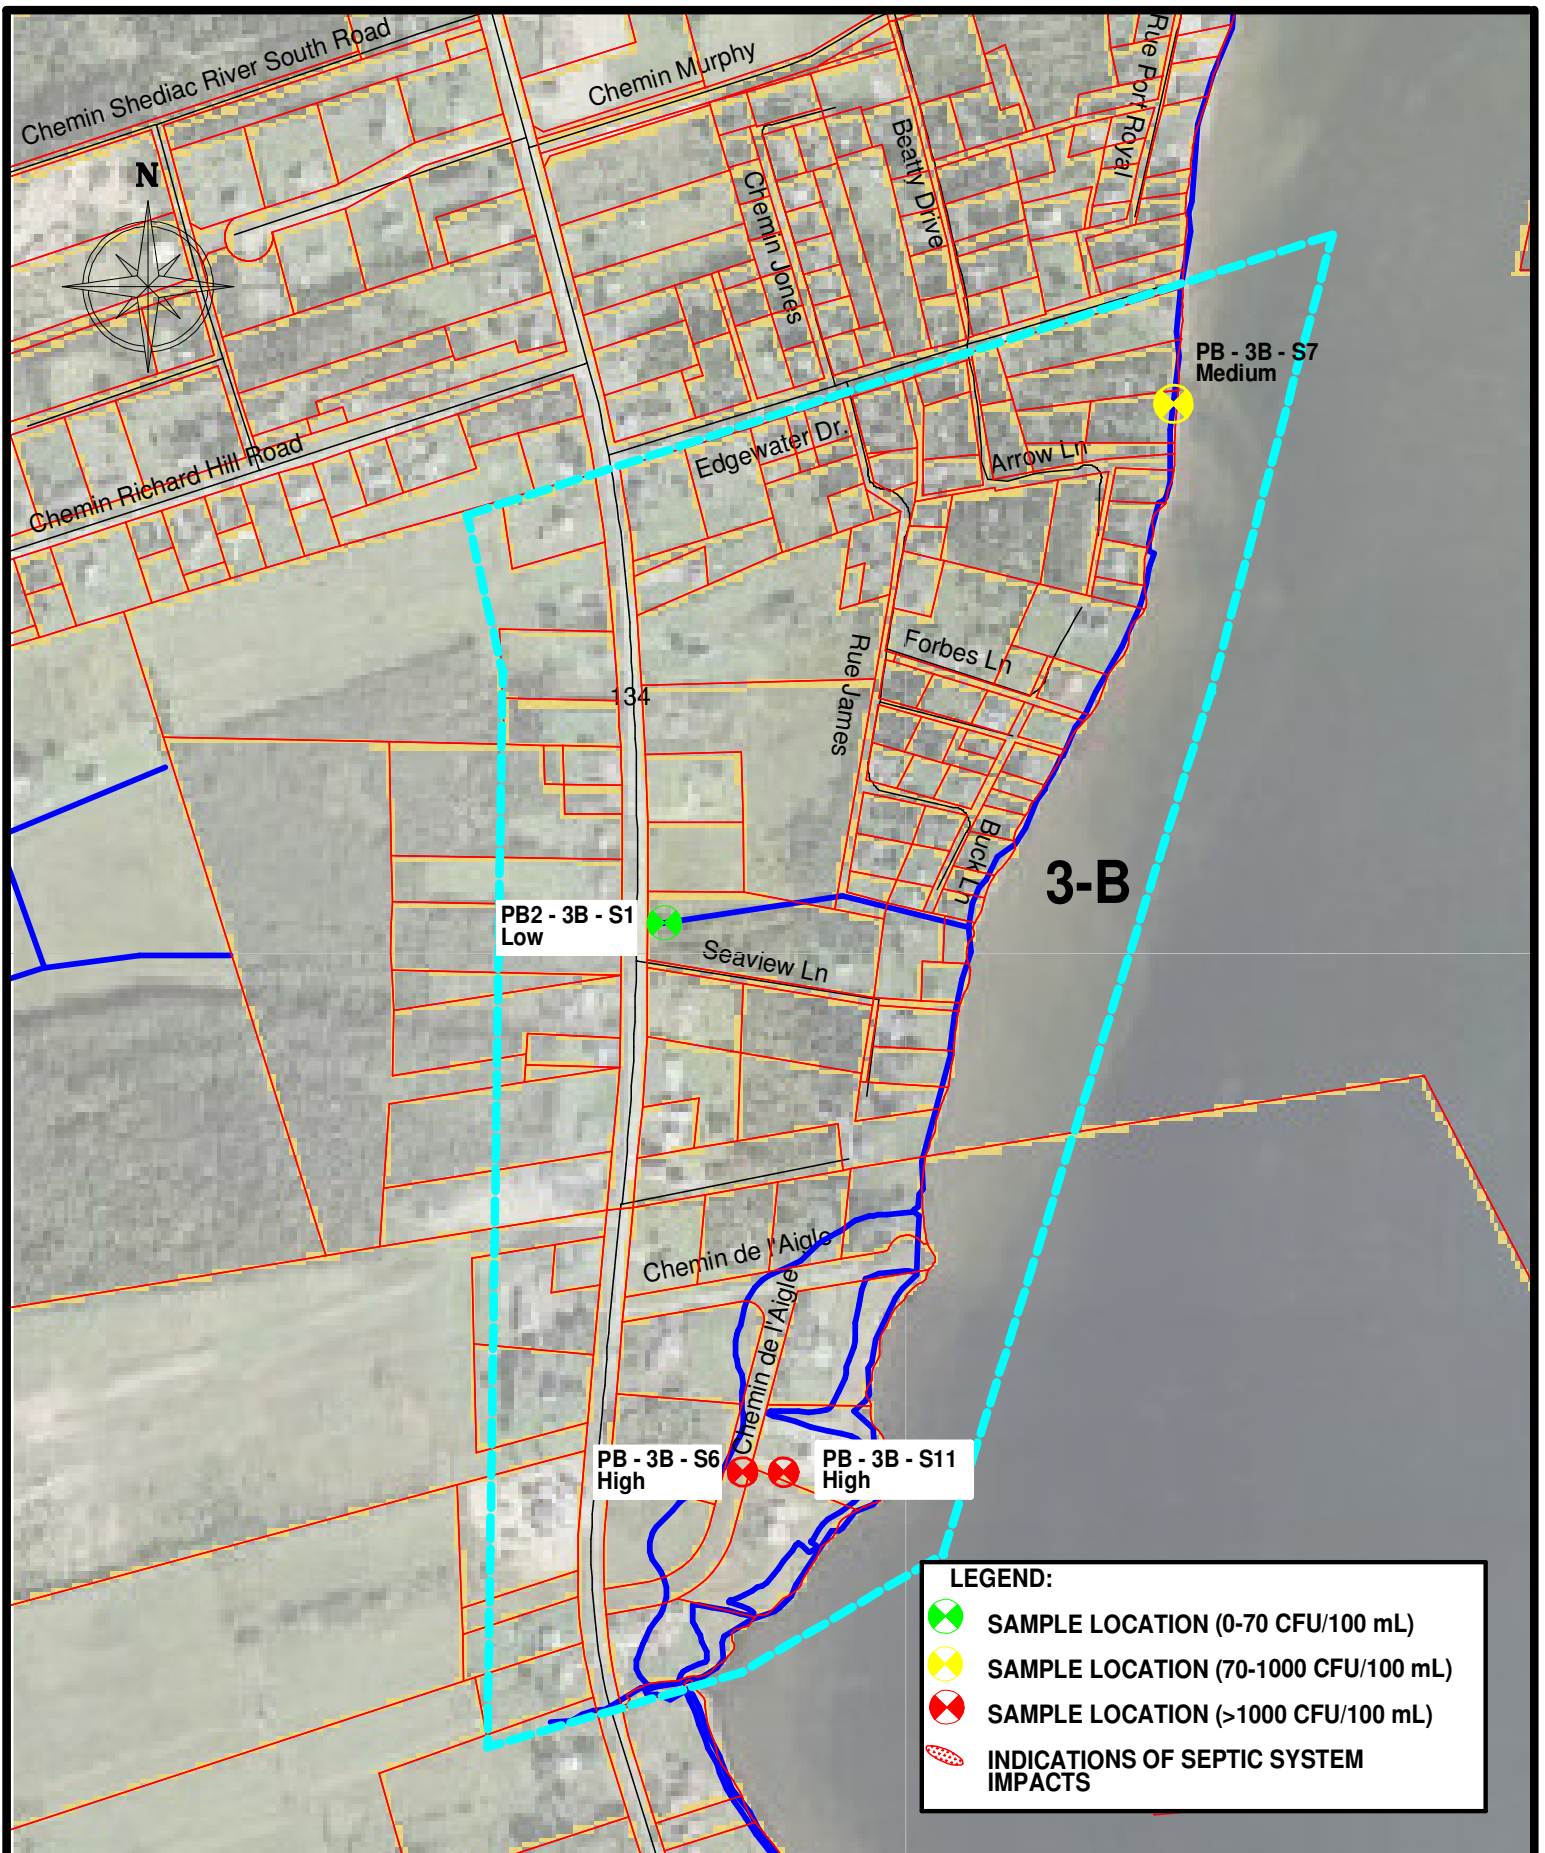
Figure:  
3-12

Assessment of On-Site Effluent Disposal Systems in the Unserviced Areas Near Parlee Beach Area 3B Test Results

A ditch in front of 23 Chemin de l'Aigle in Area 3B, was found to have E. Coli concentrations of 4,400 cfu/100 mL. Duckweed, that may be indicative of on-site sewage disposal system failure, was observed at this location, and a foul odour was detected.

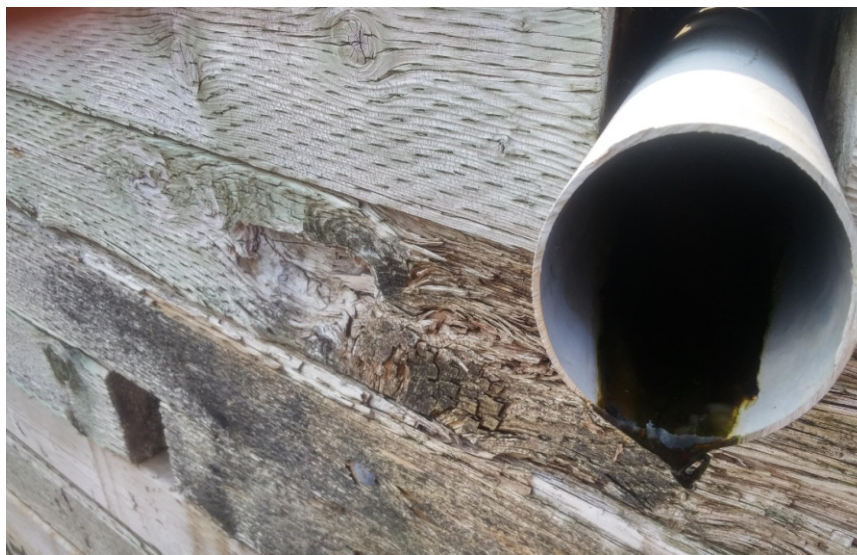
Drain pipe at beach, retaining wall in Area 2B

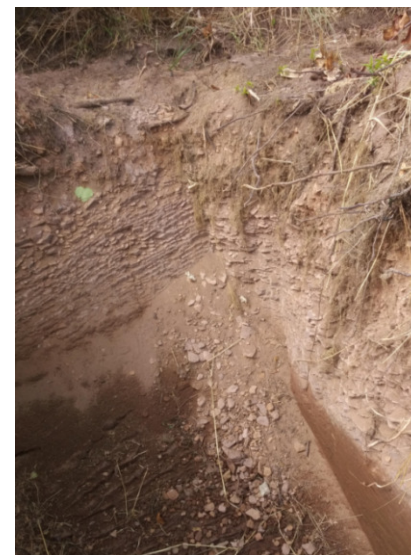
Test pit for new septic system in Area 1A

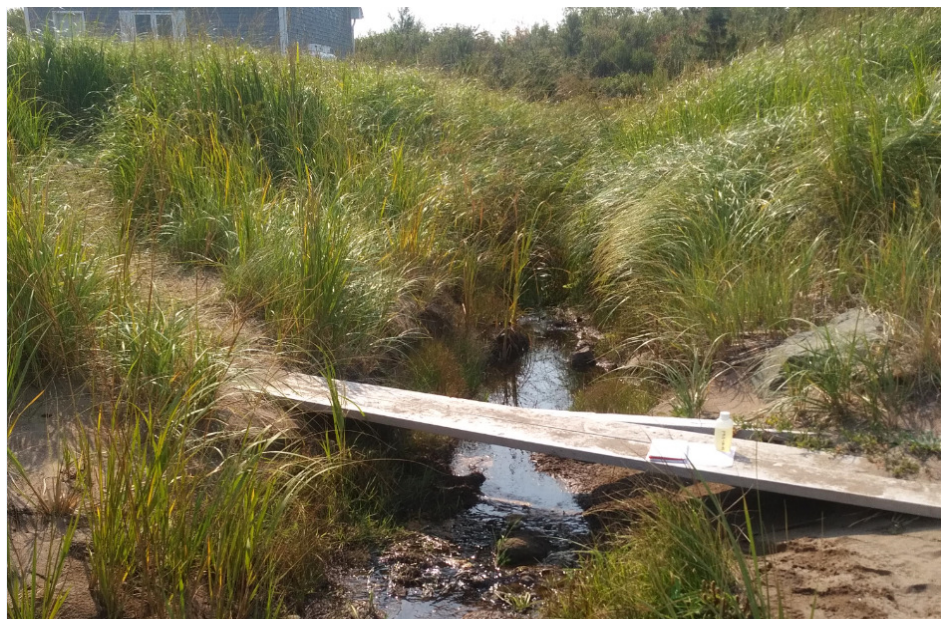
Surface discharge to beach in Area 1B

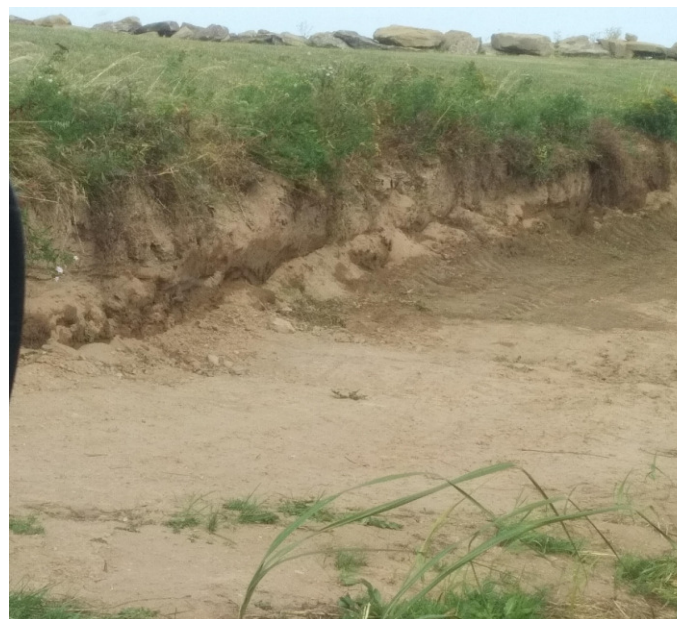
Excavation near beach in Area 1A

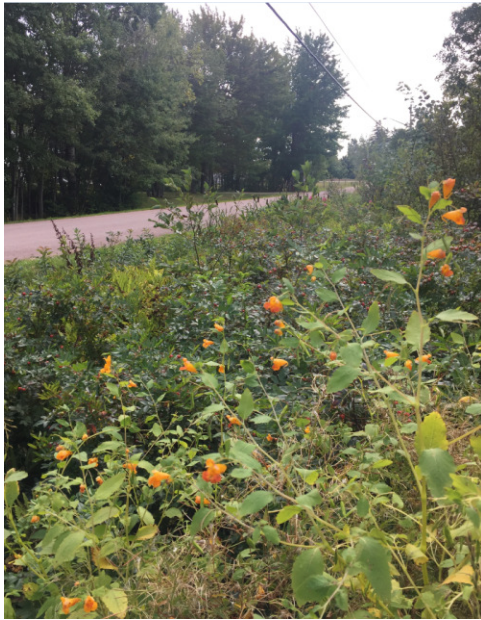
**Vegetation indicative of organic discharge in Area 1C**

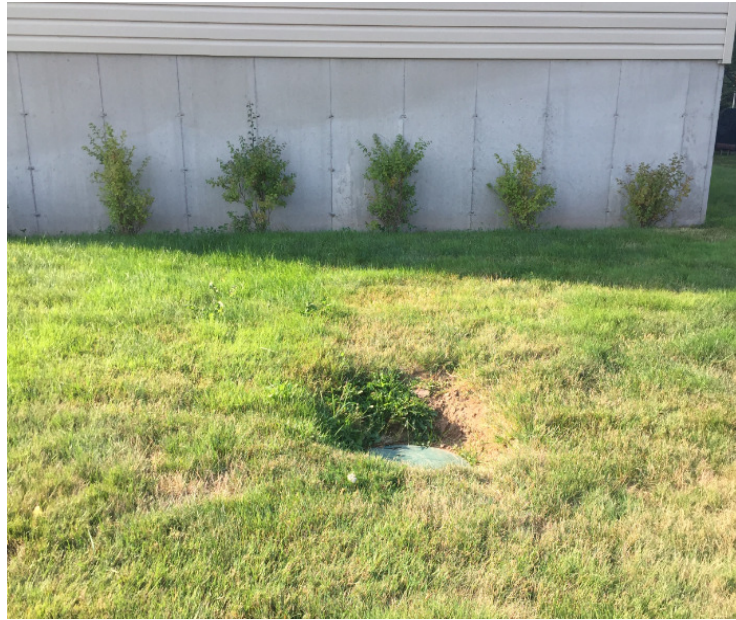
**Holding tank in Area 1A**

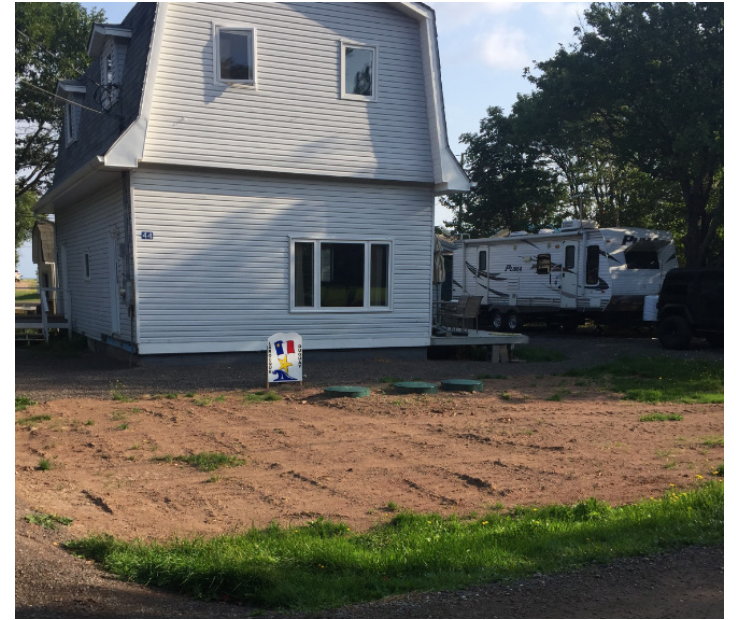
**Newly installed septic system in Area 1C**

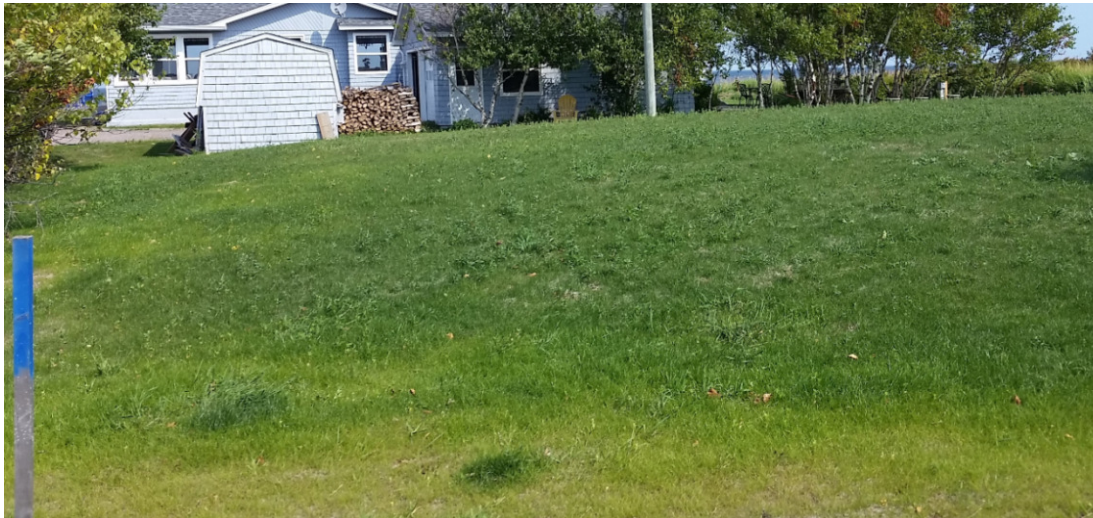
**Mound system in Area 2**

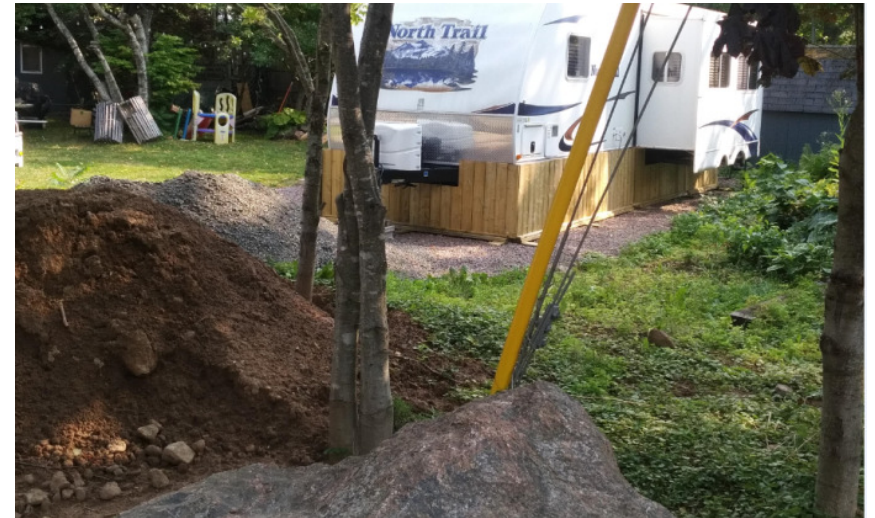
**Semi permanently placed RV in Area 1D**
