**Environmental Impact Assessment Registration Document  
(In accordance with the New Brunswick Environmental Impact Assessment Regulation)**

**Marsh Creek Wastewater Treatment Plant Decommissioning  
(City of Saint John)**

**January 26<sup>th</sup>, 2015**

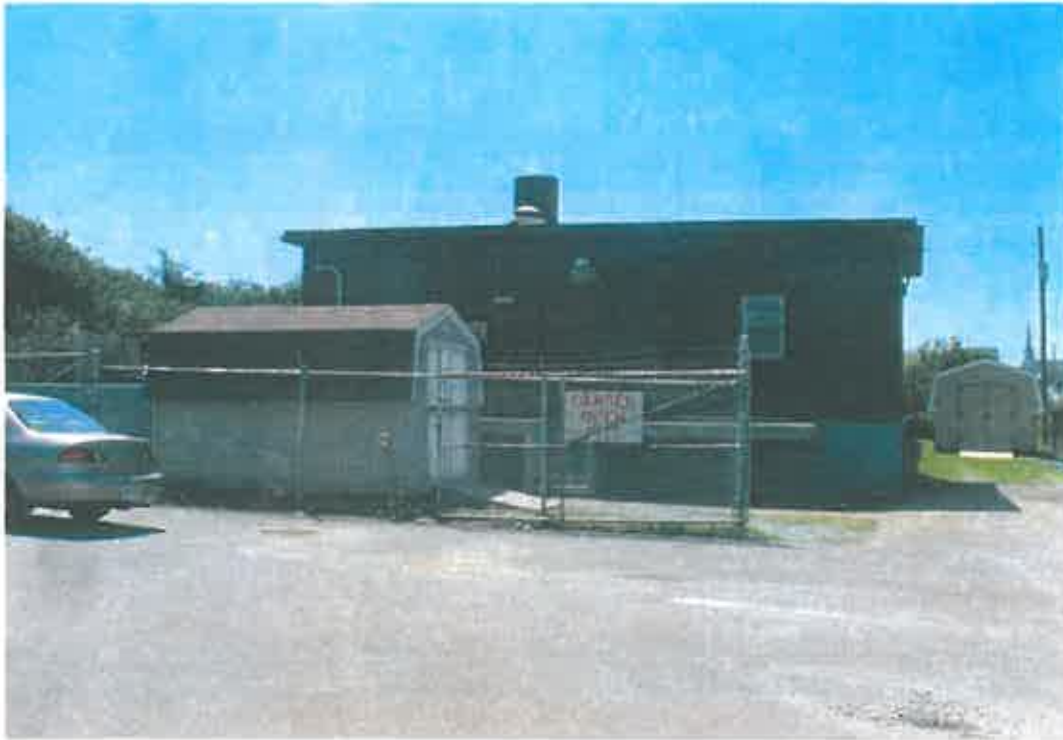
On-site buildings and structures included the one-storey Marsh Creek Wastewater Treatment Plant constructed in 1971. The building is a concrete-block structure with a flat tar & gravel covered roof and concrete foundation. The exterior walls are covered with brick. Attached to the western end of the Site building is the concrete treatment lagoon. In addition, three small wood-framed storage sheds are present on site. The remainder of the Site is covered with asphalt or lawn areas. The following is a summary of the site building information.

**Figure 1** Looking west toward the Site building.

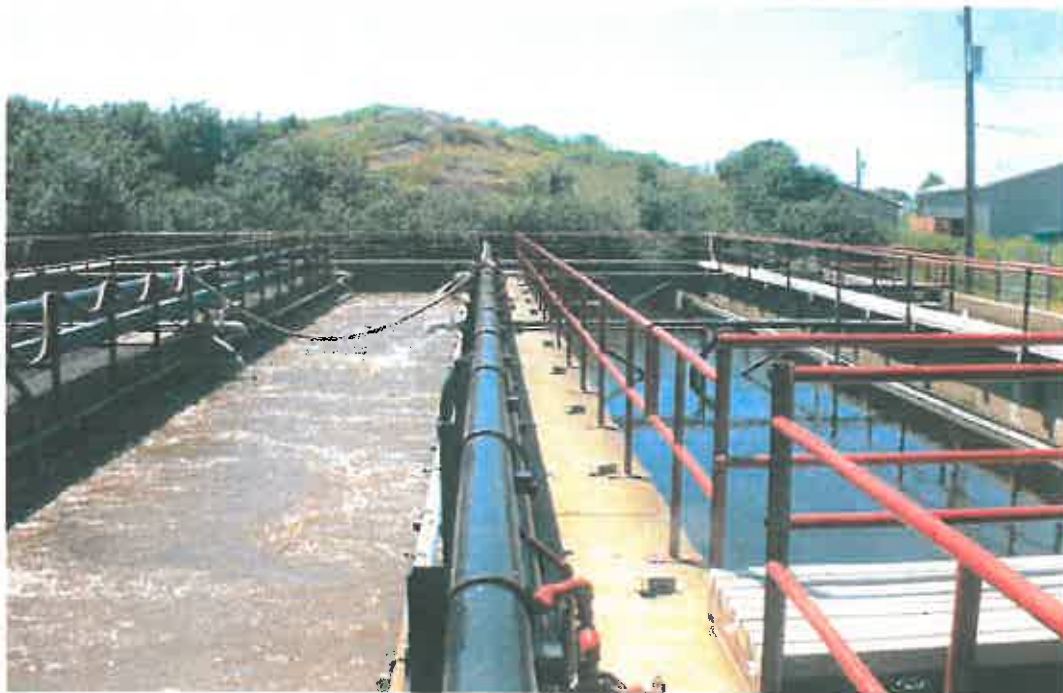
**Figure 2** Looking west toward across the treatment lagoon.
