EIA Registration – Thermalite Facility Water Supply Source Assessment (WSSA)

EIA Registration – Thermalite Facility Water Supply Source Assessment (WSSA), Cap-Pelé, NB

MON-00252430-A0

April 2019

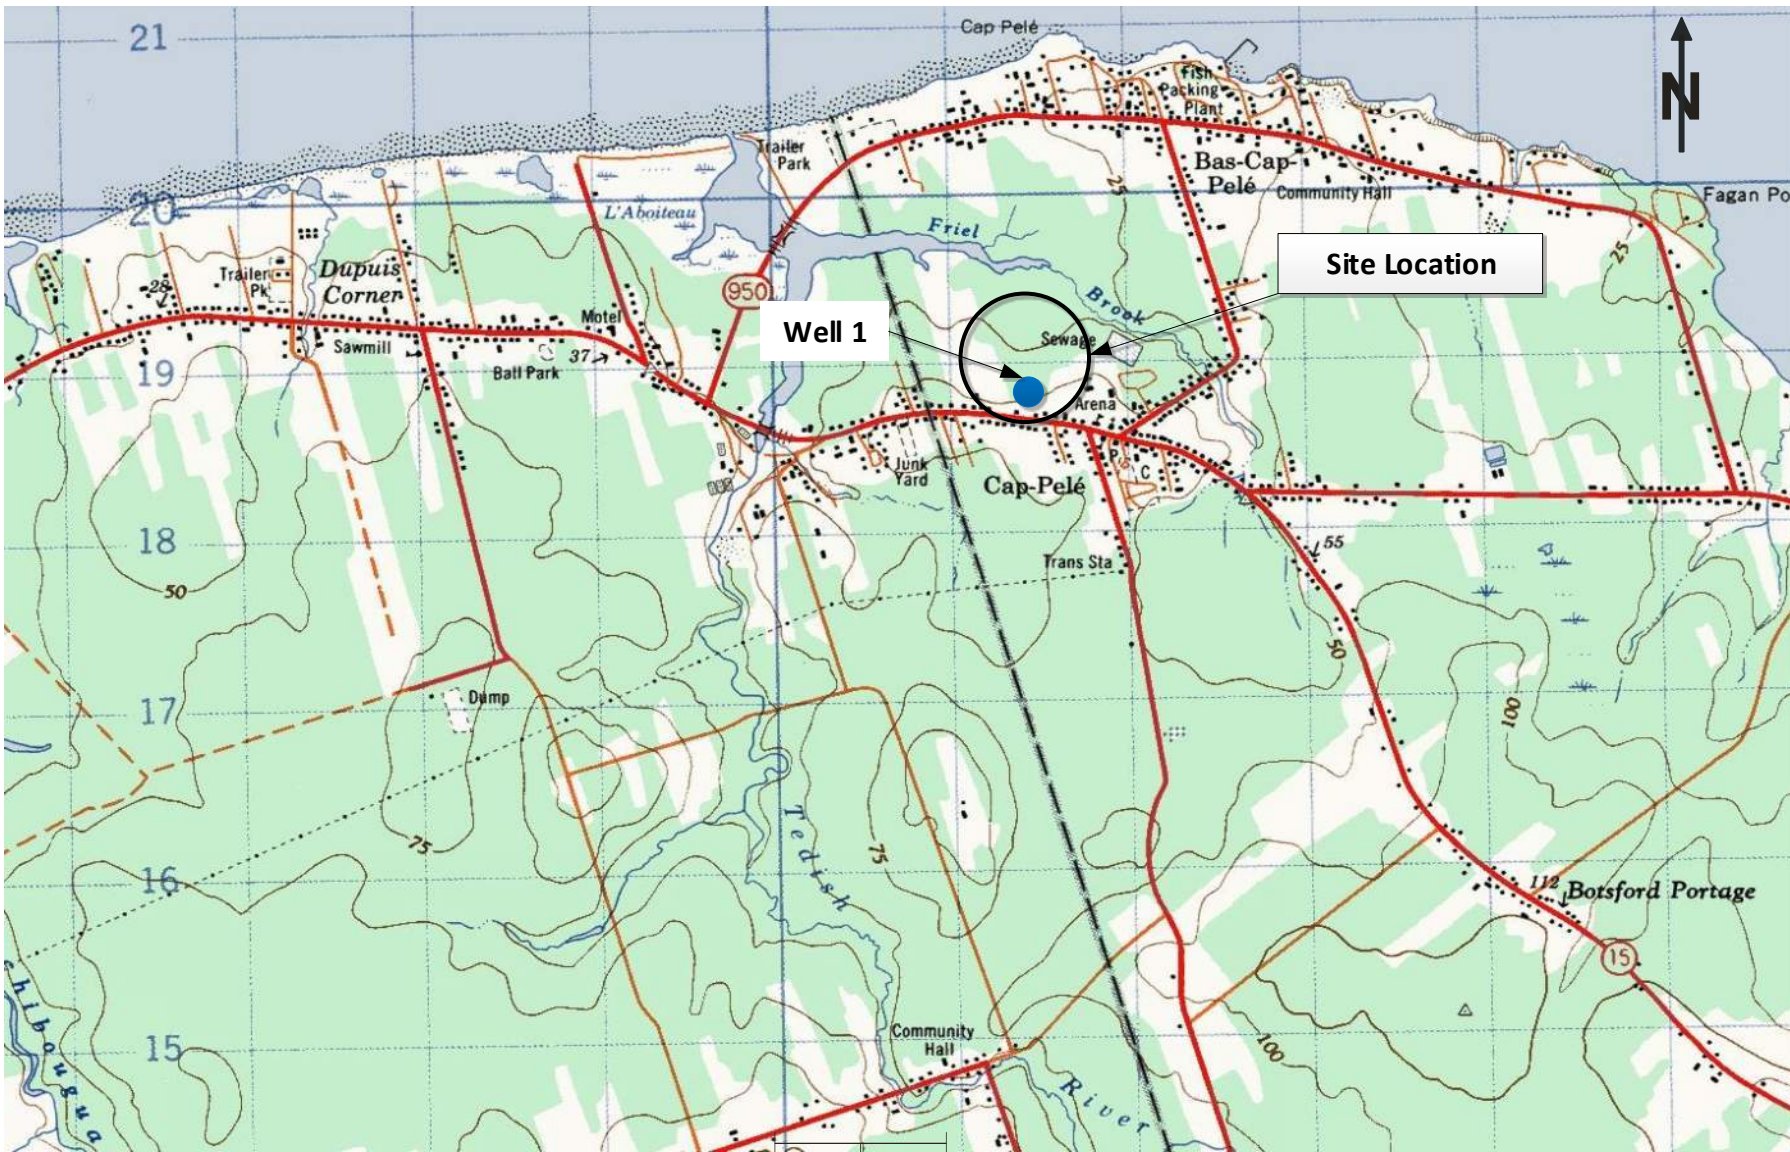
Drawn By: AMP	Project No. MON-00252430-A0	
Dwg. Standards Ckd. By:	Dwg. No. FIGURE 1	
Designed By:	Dwg. Design Ckd. By:	Rev. No.

Dwg. Title:
SITE LOCATION PLAN

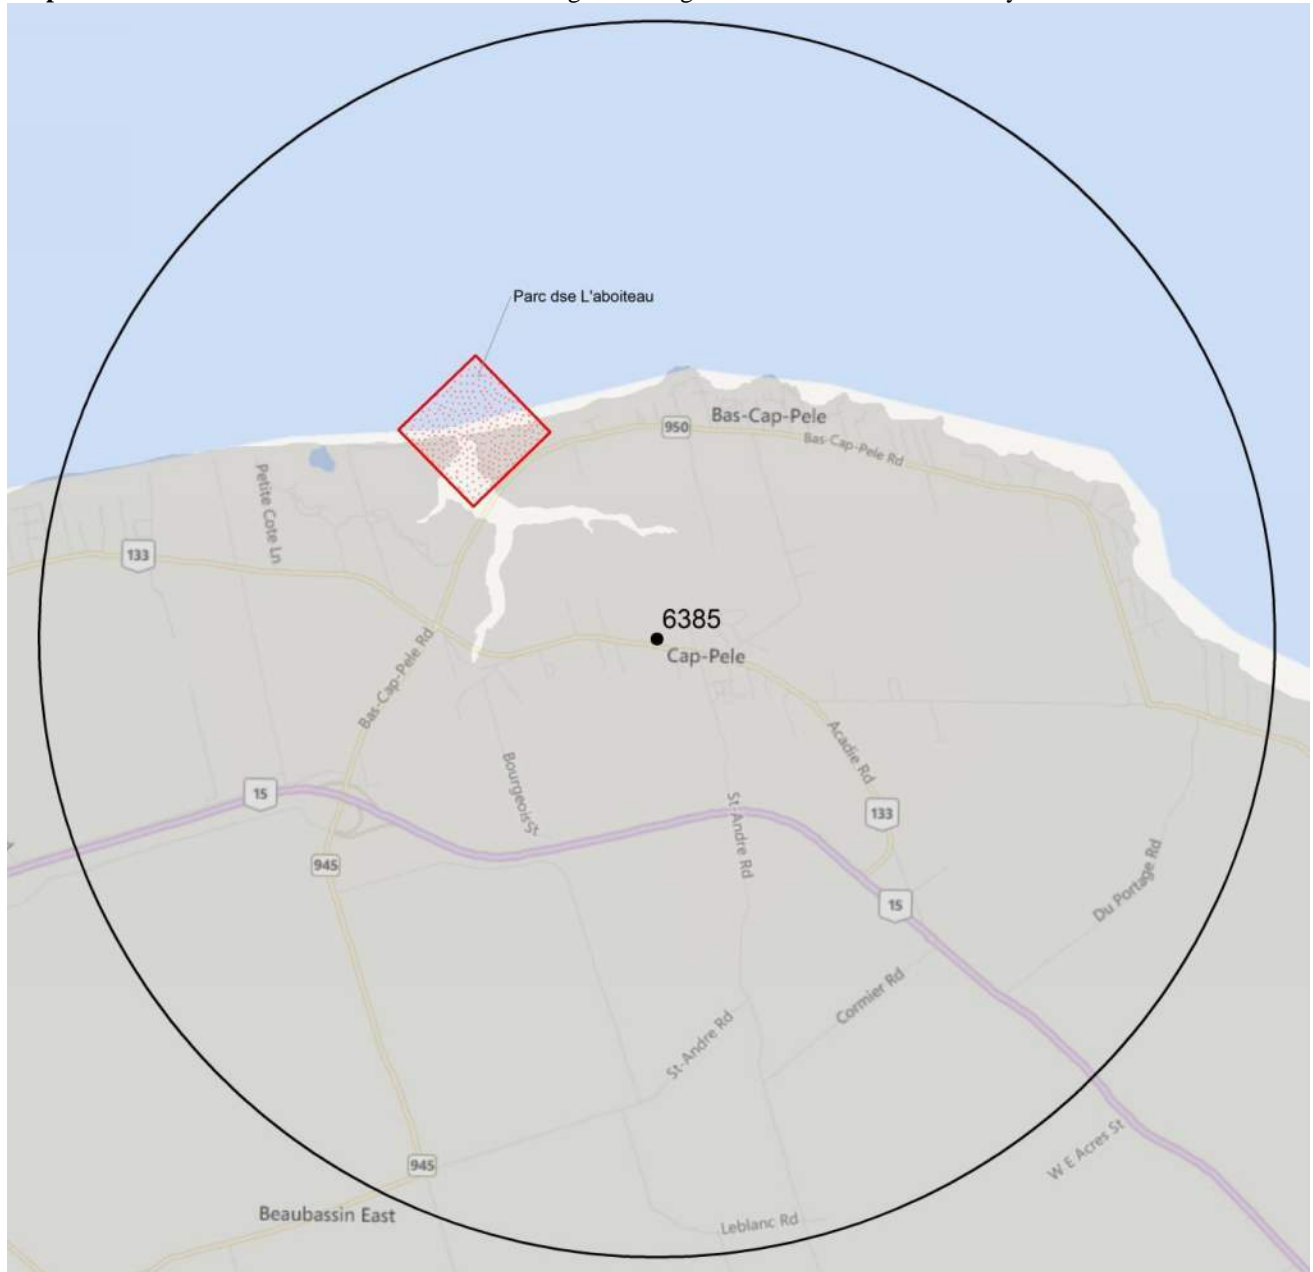
Map 3: Boundaries and/or locations of known Managed and Significant Areas within the study area.

The GIS scan identified no biologically significant sites in the vicinity of the study area (Map 3).
