VILLAGE OF PLASTER ROCK

Environmental Impact Assessment (EIA) Registration

Everett Lane Lagoon Decommissioning, Village of Plaster Rock,
New Brunswick

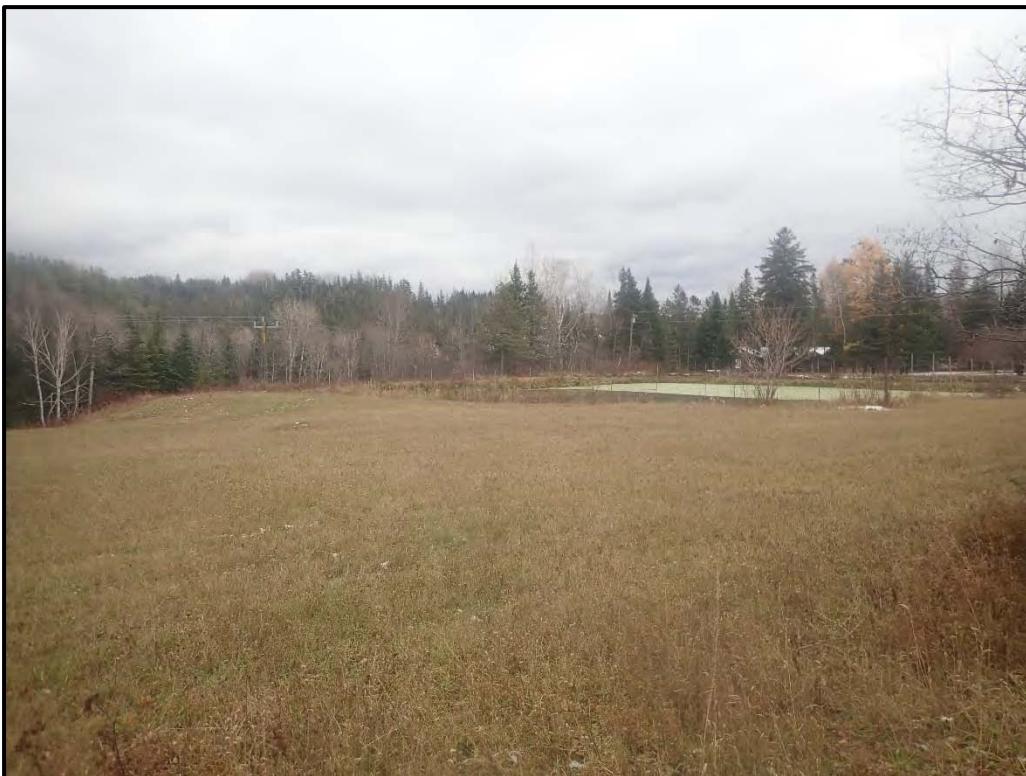
Photo 4: View southeast towards the WwTF North Lagoon, showing the anthropogenic berm surrounding the lagoon.

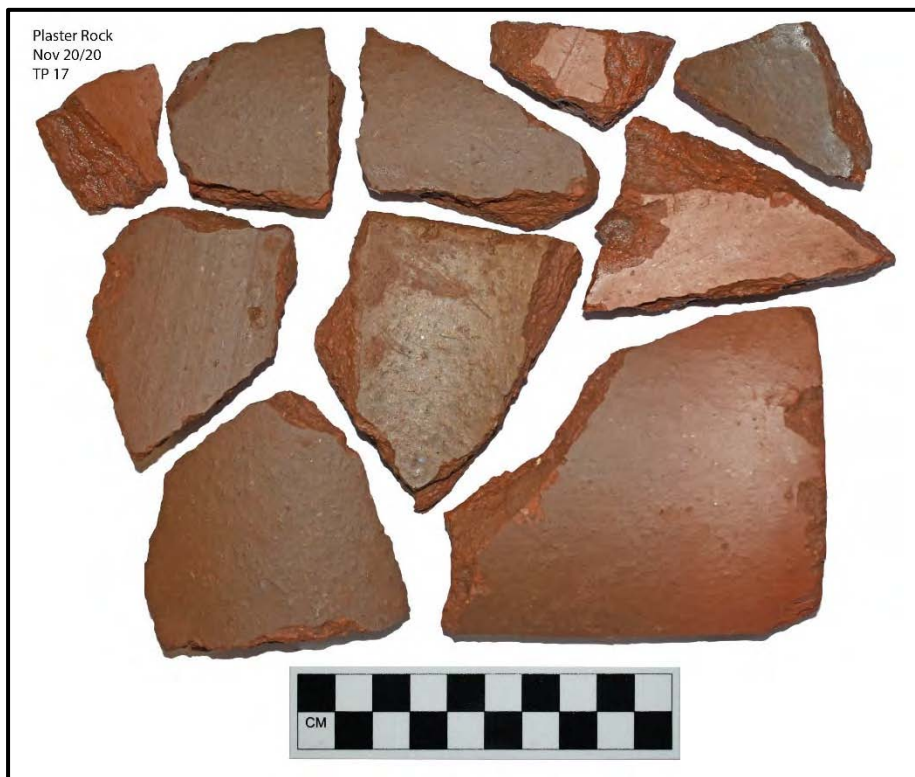
Photo 14: View of clay utility pipe identified in test-pit 17.
