**Environmental Impact
Assessment**

Inkerman Multi-use Bridge Reconstruction
Inkerman, New Brunswick

**Subject: Environmental Impact Assessment
Inkerman Multi-Use Bridge, Inkerman, NB**

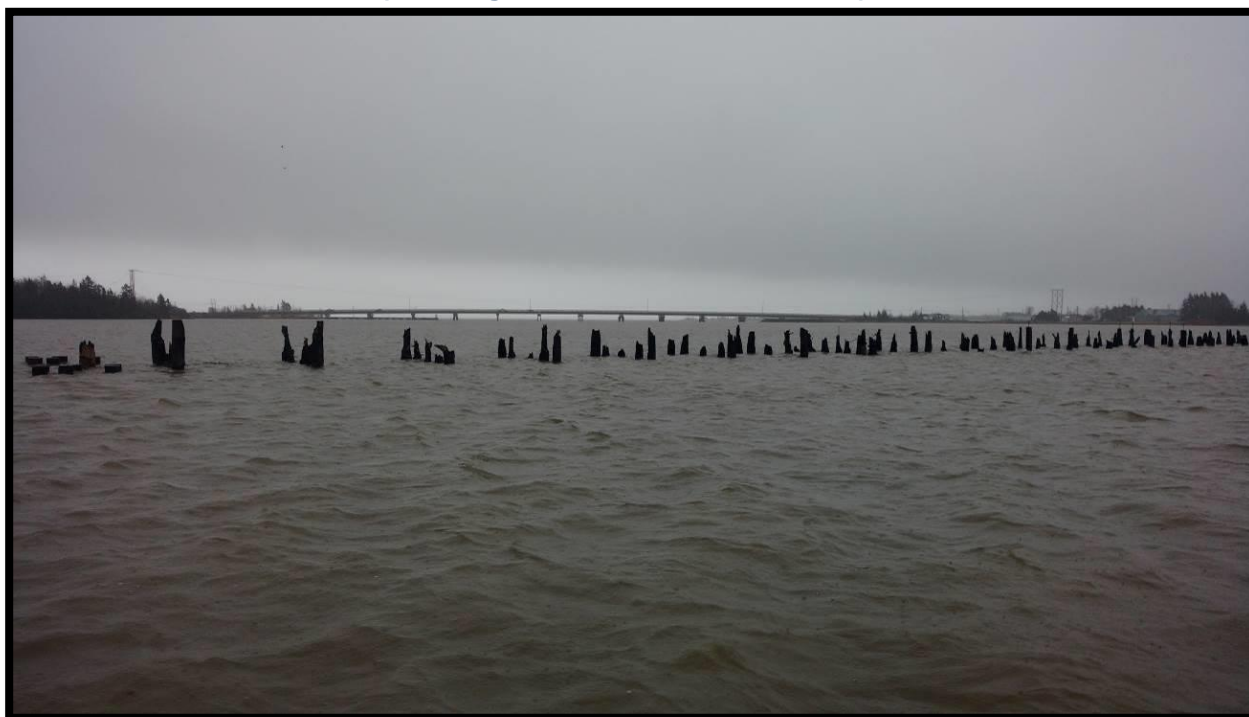
**Photo No. 4: Charred Creosote-treated Wooden Piles
(Looking South, December 6, 2017)**

The remaining, partially destroyed creosote-treated wooden piles, which are deteriorating from the 2017 fire and years of weathering, are in very poor condition. Removing the piles would likely result in breakage and localized impacts to sediments and water quality. A review of available literature shows there are both advantages and disadvantages to removing creosote-treated wooden piles, depending on their structural integrity and level of degradation. Based on available information, it is proposed that only those piles interfering with the installation of the new bridge construction or with navigation be removed.

At present, approximately 250 partially burned creosote-treated wooden piles remain in the water. Due to damage from the bridge fire and subsequent ice and water action, these piles are not usable. No provincial or federal guidelines provide guidance directly addressing the environmental risks or impacts from derelict creosote-treated piles in water. The Canada Department of Fisheries and Oceans' (DFO) "Guidelines to Protect Fish and Fish Habitat from Treated Wood Used in Aquatic Environments in the Pacific Region (2000)" provide information on the impacts from using new or recycled treated wood in fresh- and saltwater environments. However, the United States Environmental Protection Agency (USEPA) "Best Management for Piling Removal and Placement in Washington State (2016)" provides directly relevant guidance on removing creosote-laden wood from marine environments, including recommended methods of removal, and the advantages of removing them versus leaving them in place.

Based on the deteriorated condition of the creosote piles, their removal is not likely feasible – removing the piles with grapple equipment, slings or using vibration may cause the tops of the piles to break off, releasing creosote-laden debris and/or chemicals into the water. This could create localized impacts to water quality, requiring isolation of the site and collection of the material. This will also likely create impacts in the sediment around the base of the piles, as deeper material is brought to the surface and dispersed.

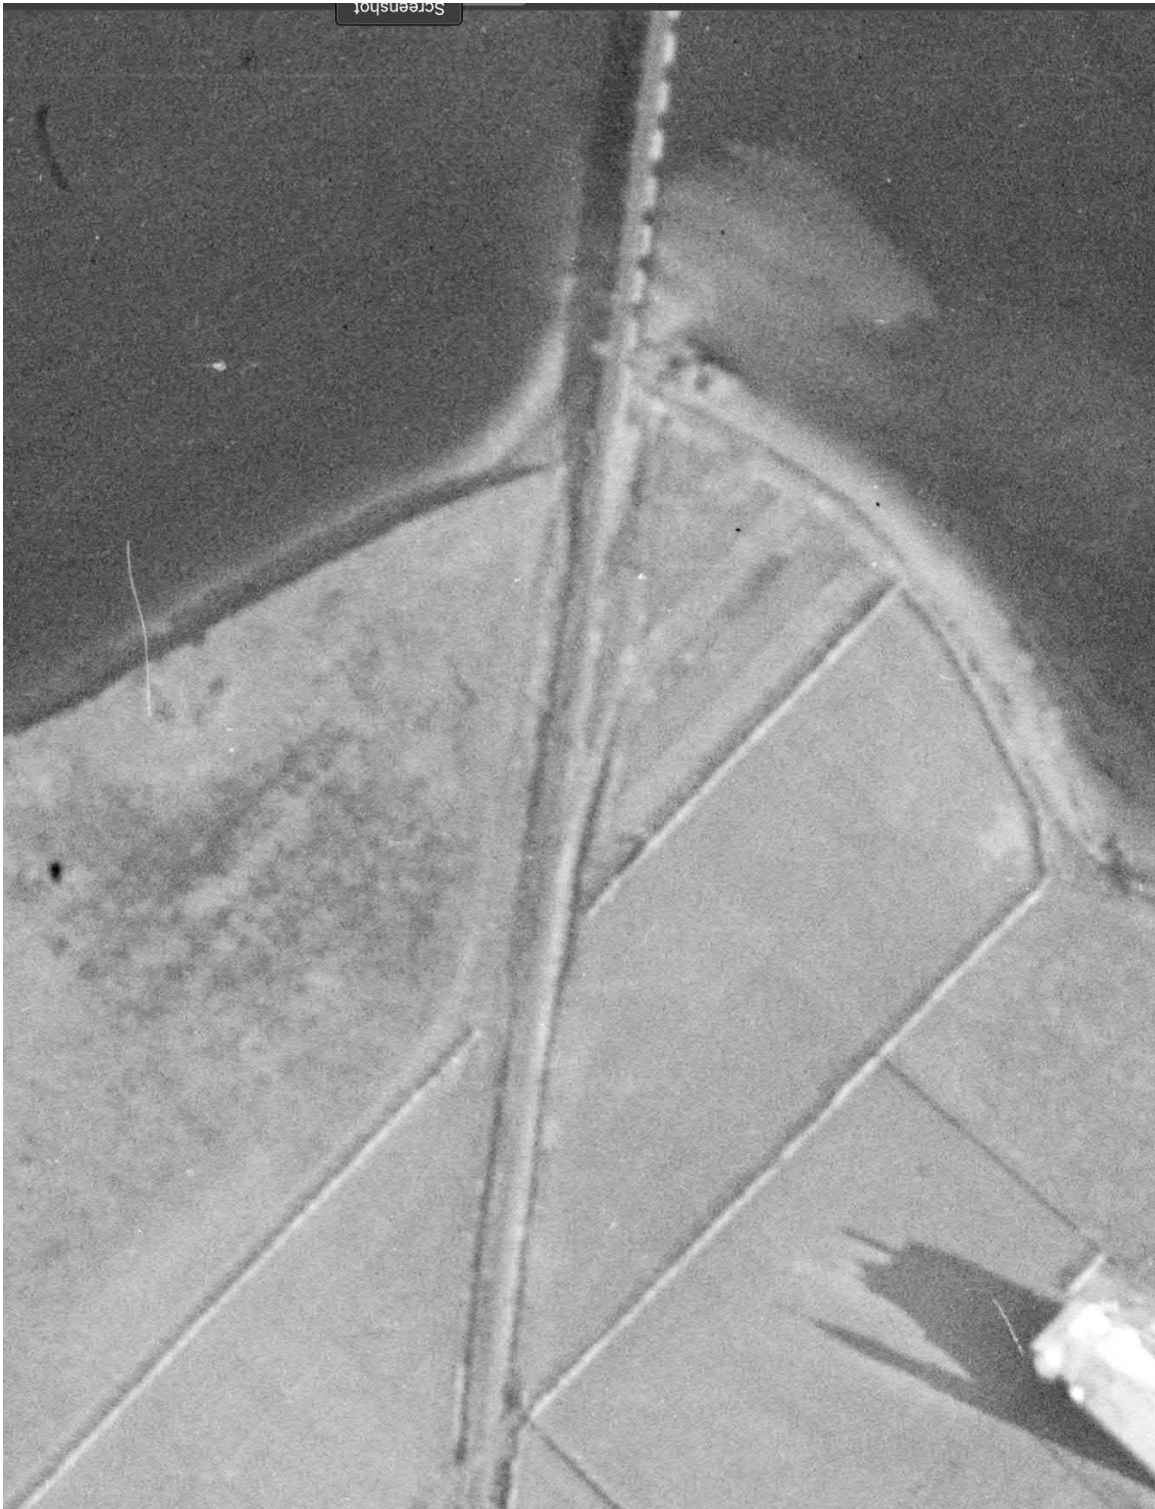
Below is a closer view of the northern assessment area from the 1944 aerial photograph. This appears to show the presence of a retaining wall west of the structure location and agricultural fields east of the structure location.

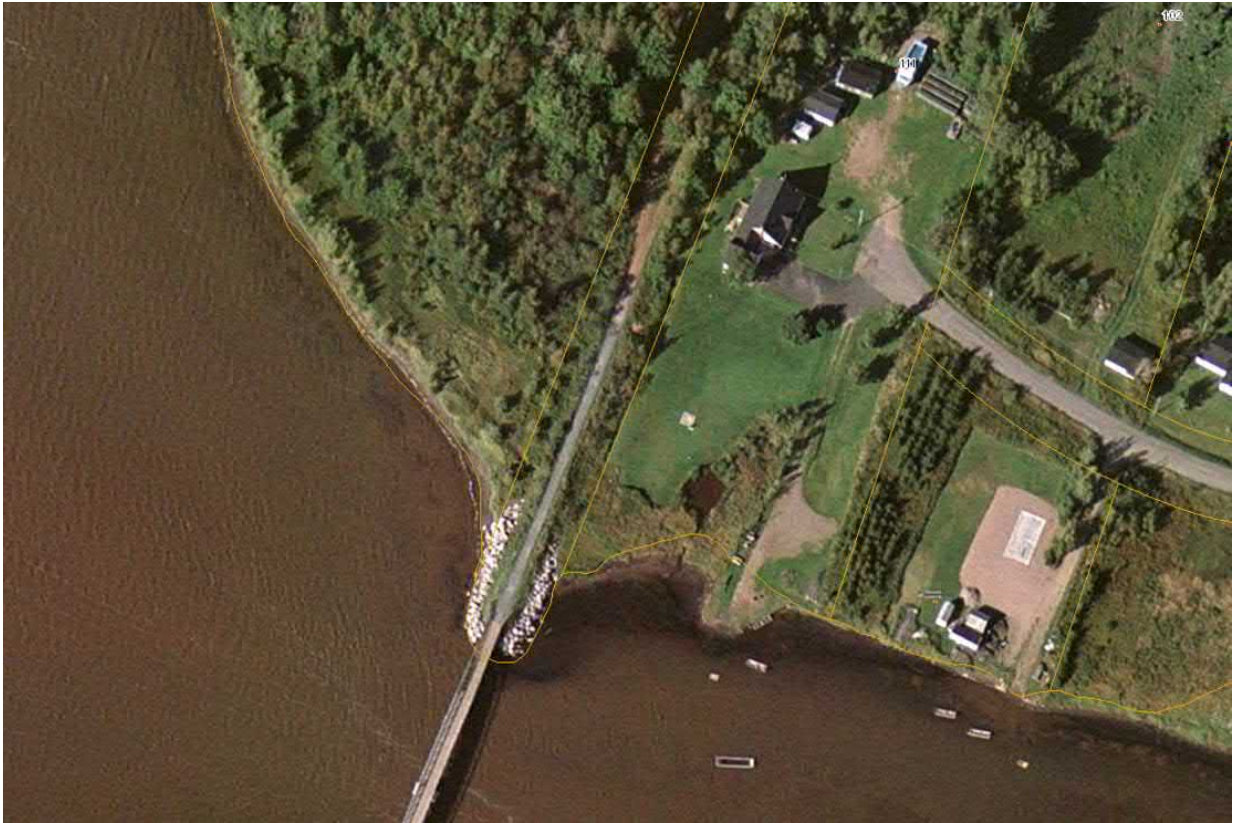
View of the southern assessment area shows fill, retaining wall, and ground disturbance approaching the structure.
