**Environmental Impact Assessment
Registration Document
JDI Deersdale On-Site Septic System
Upgrades
Deersdale, New Brunswick**

GEMTEC Project: 100083.046

June 27, 2022
GEMTEC Project: 100083.046

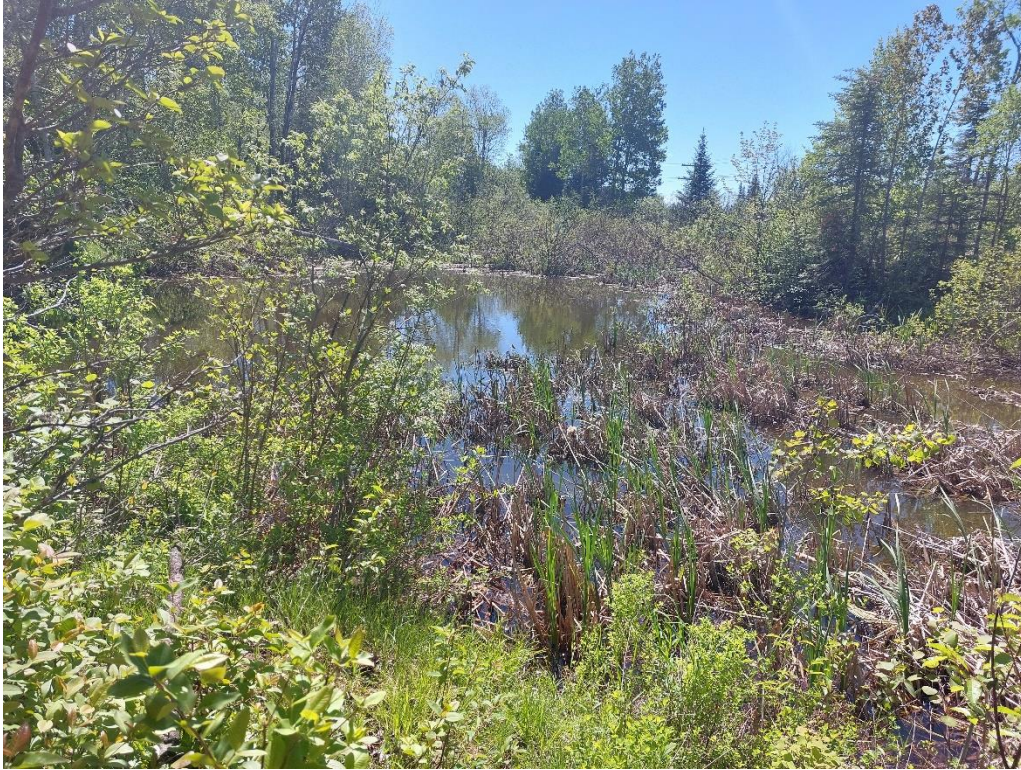
Photo 1: View of the wetland (May 31, 2022).

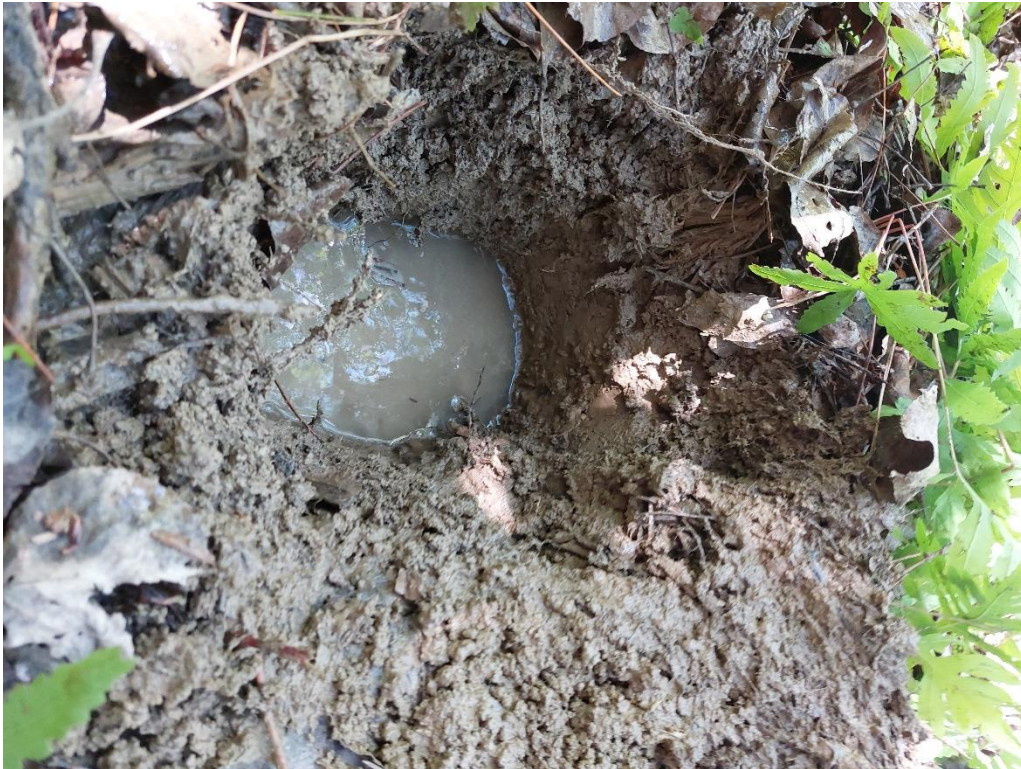
Photo 2: View of wetland soil pit (May 31, 2022).

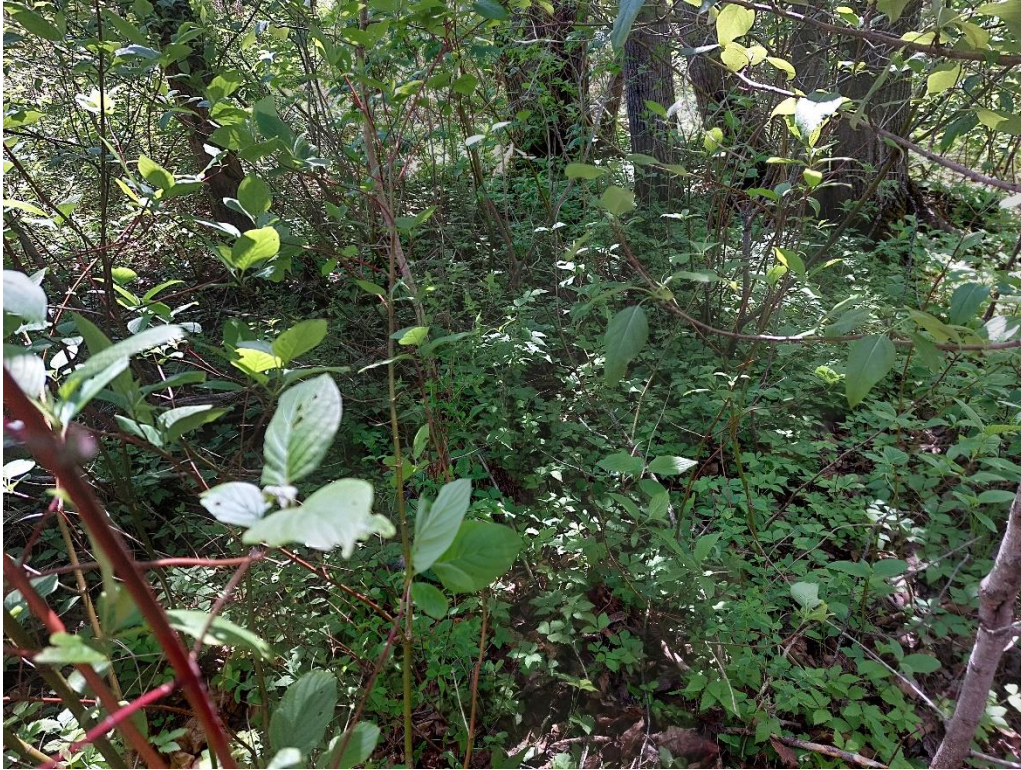
Photo 3: View of the upland (May 31, 2022).

A mixed woodland comprises the PDA and areas north of the wetland (Figure 1). The mixed woodland is dominated by Balsam Poplar (*Populus balsamifera*) and Trembling Aspen (*Populus tremuloides*). Understory vegetation is dominated by regenerating tree species. Ground vegetation included Raspberry (*Rubus idaeus*), Strawberry (*Fragaria sp.*), White Meadowsweet (*Spiraea alba*), and grass (*Grass sp.*). The woodland is described as having a closed canopy comprised of mature coniferous and deciduous trees and a relatively dense understory (Photo 3, Appendix B).

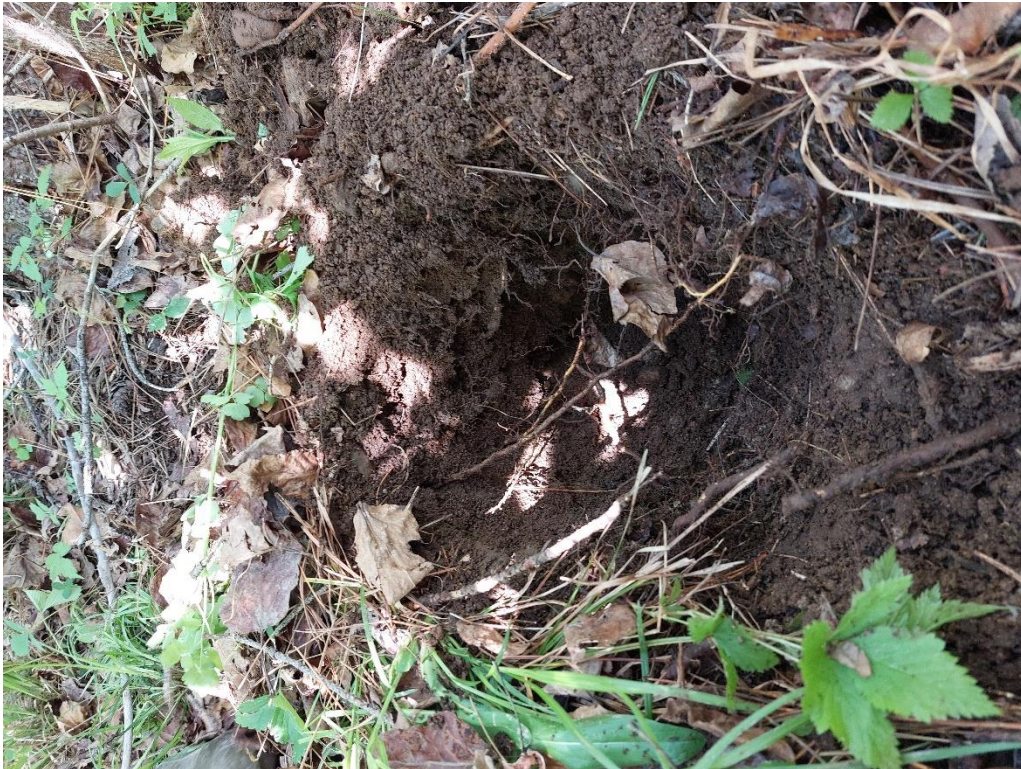
Photo 4: View of the upland soil pit (May 31, 2022).

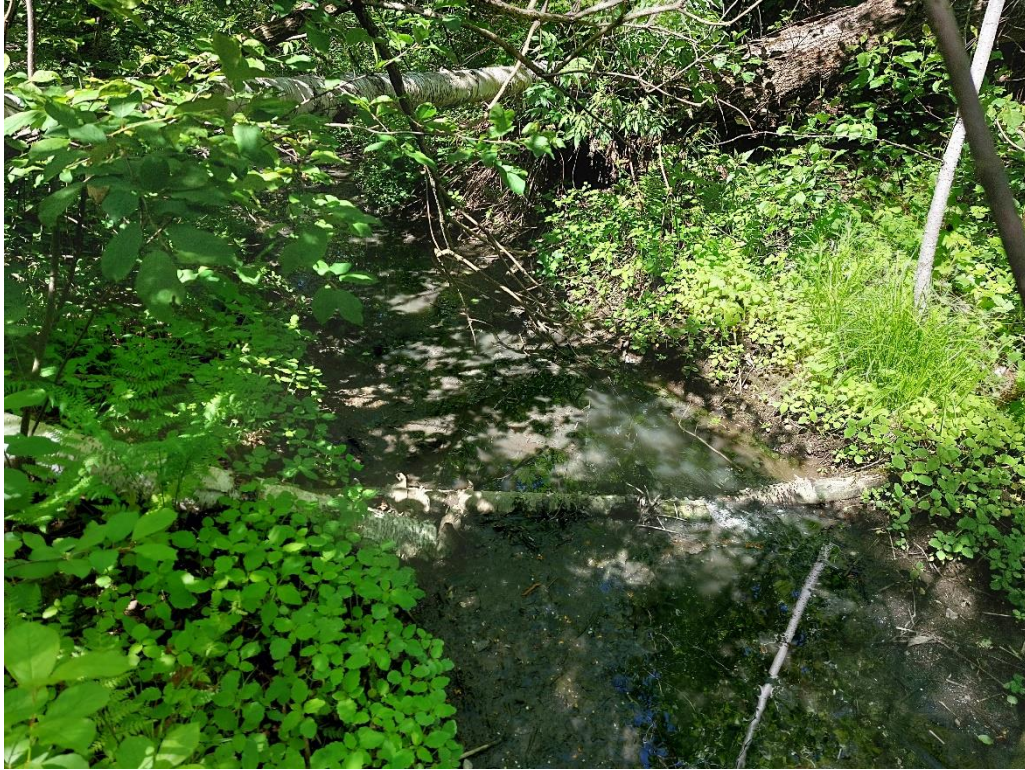
Photo 5: View of sludge in drainage channel (May 31, 2022)

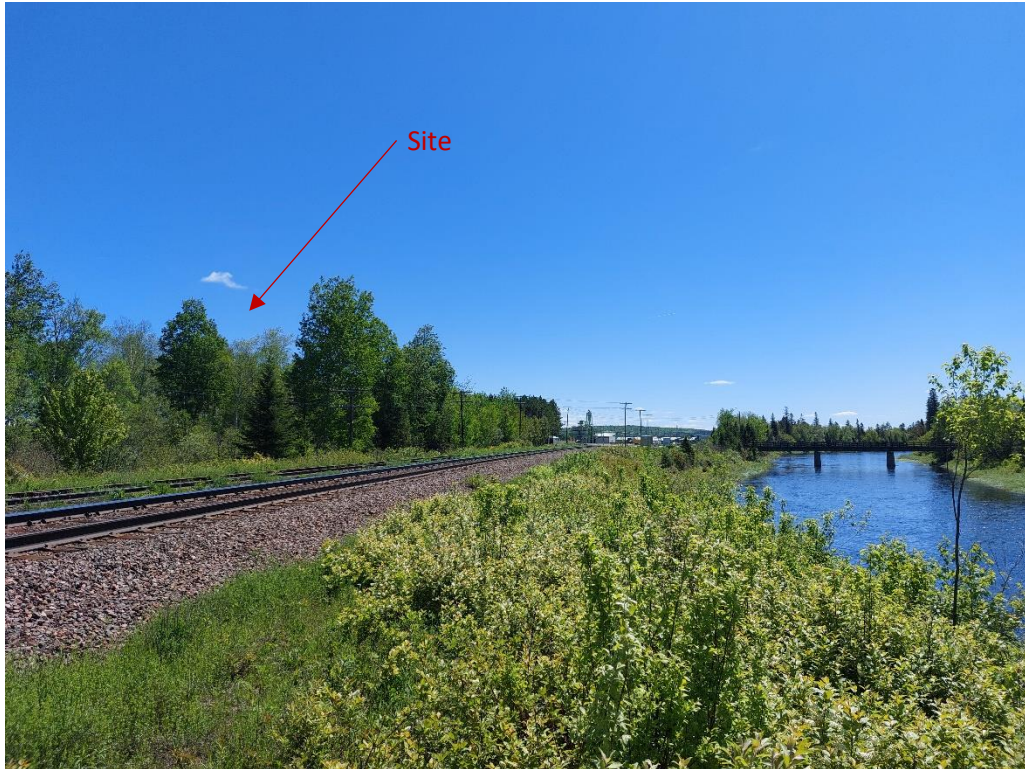
Photo 6: View of adjoining land uses (May 31, 2022).

A review of contour mapping indicates the general gradient of the PDA is sloping southwest. Downgradient flow is expected west through the nearby wetland area, then south via Five Mile Brook to outlet into the Southwest Miramichi River (Photo 6, Appendix B; GeoNB Mapping, Appendix C). The existing rail embankment serves as barrier to direct the passage of surface water flow from the PDA into the Southwest Miramichi River. The nearby wetland area currently receives hydrological inputs from existing stormwater ditching along the main camp roadways and parking lots adjoining the PDA.

A railway embankment is situated south of the PDA, spanning west to east, and creates the southern wetland boundary (Photo 6, Appendix B). Gravel roadways / parking lots adjoin the PDA to the west and east (Figure 1).

The ACCDC listed the Wood Turtle (*Glyptemys insculpta*) as a location sensitive species (*i.e.*, known to in-habitat areas within 5 km of the PDA). The Wood Turtle is listed as Threatened under *SARA* and the *NBSAR*. This species is generally found in forested habitats and require daily water resources; thus are associated with clear, freshwater streams and the associated floodplains. The preferred streams contain a year-around flow with substrate beds of sand, gravel and sometimes cobble. Wood Turtles also use bogs, marshy pastures, beaver ponds, oxbow lakes, riparian and shrub areas, meadows, hay and agricultural fields, and transmission line right-of-ways (*SARA*, 2021). These habitats were observed along the Southwest Miramichi River, located approximately 150 metres from the PDA. The rail embankment and rail infrastructure creates a migration barrier between the watercourse and the PDA (Photo 6, Appendix B); therefore, the occurrence of Wood Turtles in the PDA is considered low.
