## **Status Review of On-Site Sewage Disposal in the Unserviced Areas near Parlee Beach**

**Submitted to:** NB Department of Health  
520 King Street, HSBC Place  
Fredericton NB  
E3B 6G3

**Prepared by:** NATECH Environmental Services Inc.  
2492 Route 640  
Hanwell, N.B.  
E3E 2C2

**Date:** December 15, 2017

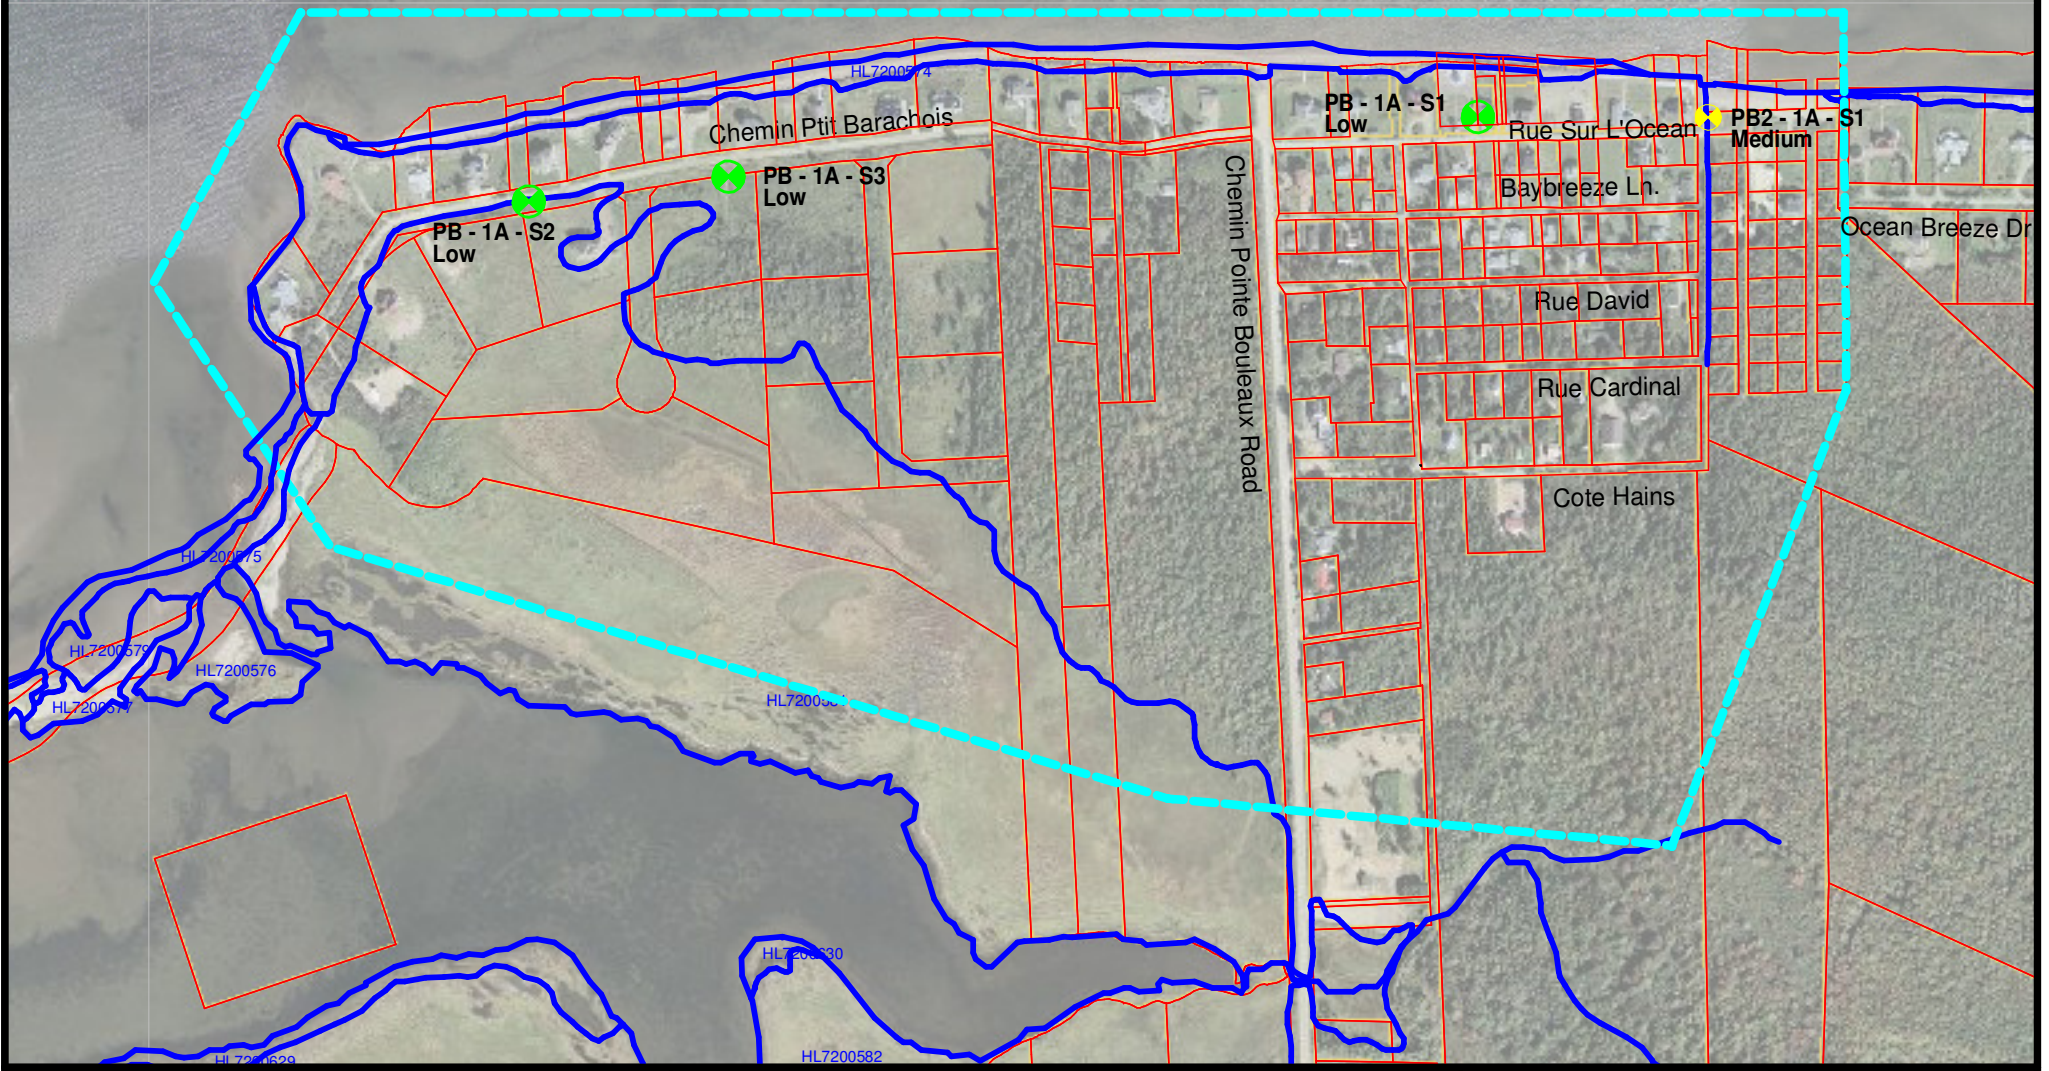
Date:	2017/11/24	Date:		Project No.:	PBS-17-01
Scale:	AS SHOWN	Echelle:		Figure:	3-5

Assessment of On-Site Effluent Disposal Systems  
in the Unserved Areas Near Parlee Beach  
Area 1A Test Results

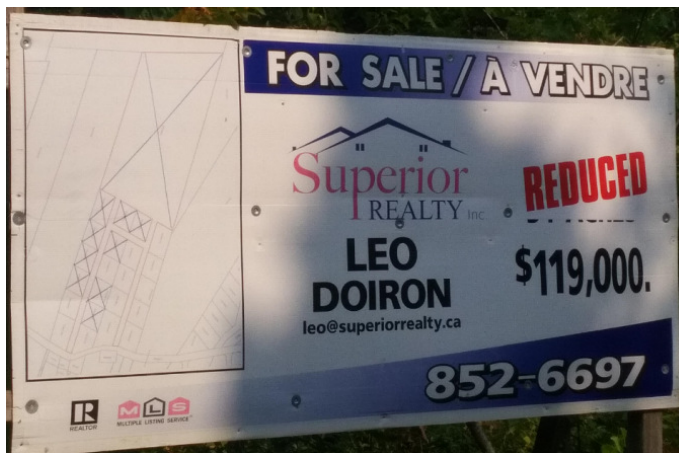
For sale sign in Area 1C
